Seward Ship's Drydock

Location: Seward, Alaska
Application: Ship dry dock cover
Building Series: TITAN®
Building Size: 110' x 220'

Harsh conditions no match for Cover-All® TITAN® building

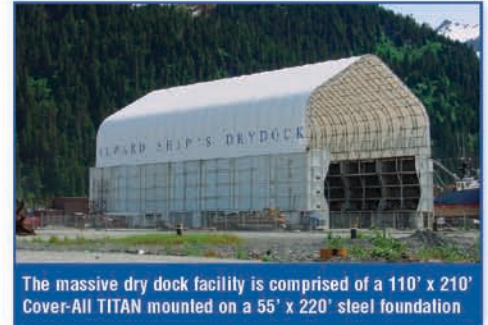
The massive dry dock facility is comprised of a 110' x 210' Cover-All TITAN mounted on a 55' x 220' steel foundation

"We literally shopped the world for 10 years to create what we have today," says Don Whitman, general manager, Seward Ship's Drydock. The impressive structure is comprised of a 110' x 210' Cover-All® TITAN® building mounted on a 55' x 220' steel foundation. The foundation is constructed of submarine enclosure modules that sat on the site without a cover since 1998 while the search continued for the ideal building solution.

- The 55' x 220' steel foundation is submarine enclosure modules that were going to be used in the process to attach stealth plating to the sides of submarines; when the process didn't work, they were the perfect alternative solution for high permanent walls needed for this project instead of steel walls or driving H-beam piles into the ground

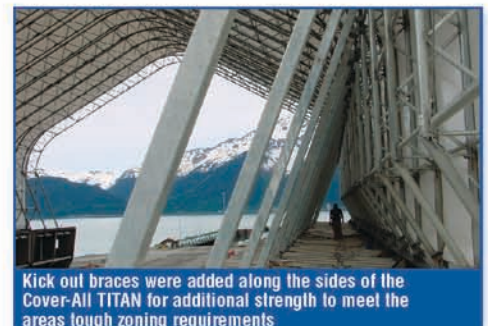
Kick out braces were added along the sides of the Cover-All TITAN for additional strength to meet the areas tough zoning requirements

- Twenty-four 15' long by 3/8" thick reinforced steel kick out braces were added along the sides of the TITAN® for additional strength to meet the area's tough zoning requirements
- In order to achieve the 110' building height needed to service ships, custom 12' wall extensions were added to the TITAN®

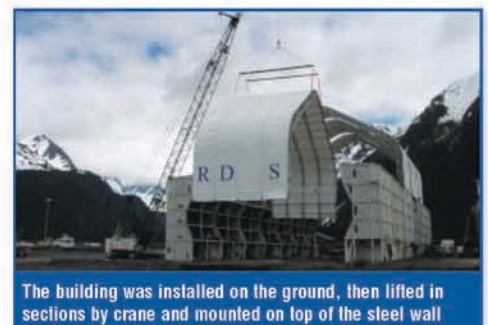
The building was installed on the ground, then lifted in sections by crane and mounted on top of the steel wall

The Cover-All® TITAN® building's steel trusses were constructed in five separate sections on the ground then lifted by crane onto the foundation. Once the sections were in place, a specialized winch was used to position the fabric panels and join the sections together to complete the building cover. The installation of the Cover-All® building was complete in just 14 days.

- The heaviest section of the Cover-All® building lifted onto the foundation was 17,000 lbs, so spreader bars and straps were certified to meet 51,000 lb strength tests
- A crane was used to lift the steel trusses into place to complete the building installation
